**Flood Control Project Maintenance
Levee Inspections**

Fall 2019 Levee Maintenance Deficiency Summary Report

Sacramento River Basin

Reclamation District No. 1500 Sutter Basin

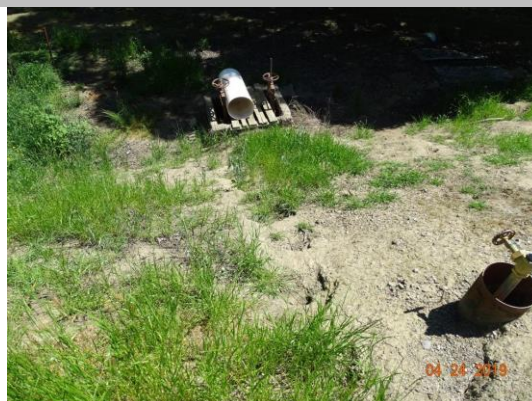
Photo 1 of 1 : FA_2019_RD1500_189_145_20190829_00068.jpg

LM Start	0.31	Rating **	M	Issue No.	145
LM End	0.31	Issue Type +	En	Location *	LS
Category	Earthen Levee			GPS Latitude/Longitude	
				Start	End
Item	Encroachments			38.763230 °	38.763230 °
				-121.679014 °	-121.679014 °
DWR ID	DWR_RD1500_01_f_2018_145				
Comment Code					
ST : Stairway					
Inspector Comment					
Stairs are dug into the landside slope.

View of stairs on the landside slope. Spring 2019.

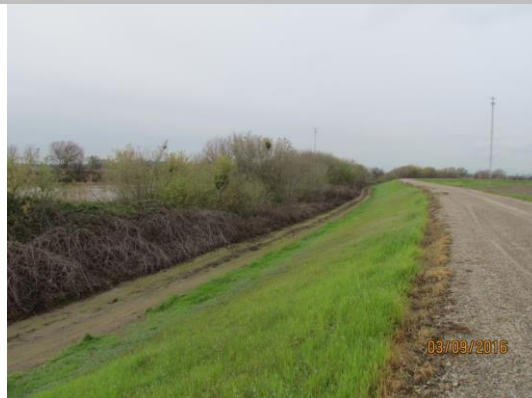
Photo 1 of 2 : FA_2019_RD1500_189_72_20190829_00024.jpg

LM Start	0.56	Rating **	A/W	Issue No.	72
LM End	0.82	Issue Type +	Ob	Location *	WS
Category	Earthen Levee			GPS Latitude/Longitude	
				Start	End
Item	Vegetation			38.764462°	38.764638°
				-121.683167°	-121.687690°
DWR ID	DWR_RD1500_01_s_2018_72				
Comment Code					
V8 : Environmental Requirements.					
Inspector Comment

View of the revegetation site on the waterward side toe of the levee looking upstream. Spring 2016.

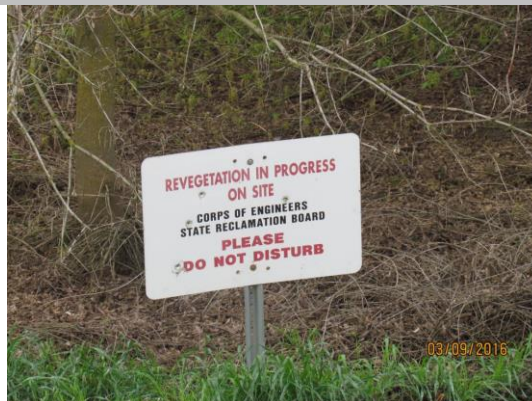
Photo 2 of 2 : FA_2019_RD1500_189_72_20190829_00025.jpg

Sign is located at the toe of the levee on the waterward side. Spring 2016.

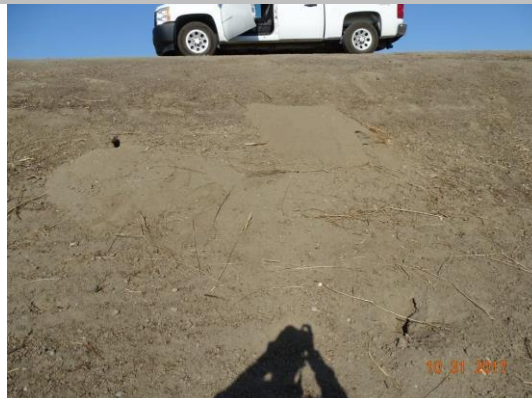
Photo 2 of 2 : FA_2019_RD1500_189_99_20190829_00043.jpg

LM Start	1.25	Rating **	M	Issue No.	99 (cont)	
LM End	1.25	Issue Type +	Ma	Location *	LS	
Category	Earthen Levee			GPS Latitude/Longitude		
				Start		End
Item	Animal Control			38.769274 °		38.769274 °
				-121.691700 °		-121.691700 °
DWR ID	DWR_RD1500_01_f_2017_99					
Comment Code						
A3 : No rodents visible, but rodent burrows visible; need to backfill and compact or grout burrows.						
Inspector Comment						
There are multiple rodent holes and mounds on the landside slope.

View of holes and mounds on landside slope. Fall 2017.

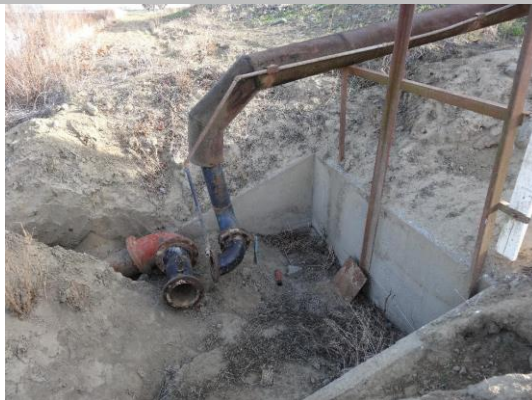
Photo 2 of 3 : UCIP_FA_2019_28903_53161.jpg

DS_ID:20094
FS_ID:28903
EP_NO: 10080
Repair Type: Non-Urgent
Crossing Status: Found
UCIP Comments: Pump removed from concrete pad and kept inside pump house (may be for storage purpose) on waterside. A 8-inch steel pipe inside 14-inch pipe.
FIELD_STRUCT_DESC: 1 of 2: 14-inch steel irrigation discharge pipe through the levee, 5.2 feet below the crown. Pump in a corrugated metal pump house on the waterside (WS) slope. Butterfly valve on the WS. Concrete staircase on the WS slope. 1.75-inch galvanized iron water line with faucet exposed on the landside (LS) slope, 3.4 feet below the crown. 4-foot by 5.7-foot concrete distribution box at the LS toe. 1.25-inch conduit through levee, 2 feet below the crown. (14-inch steel irrigation discharge pipe through the levee and pump in a corrugated metal pump house on the WS slope authorized under Automatic Board Order (ABO) issued as Permit No. 10080, 1974 - Sebastian Yturralde). [Additional Reference(s): DWR Levee Log, 2005. USACE Sacramento O&M Manual 128, March 1960, (HLM 1.28)].

WS view: U type headwall and 8-inch pipe sleeved into 14-inch steel pipe. Pump was removed from the pipe.

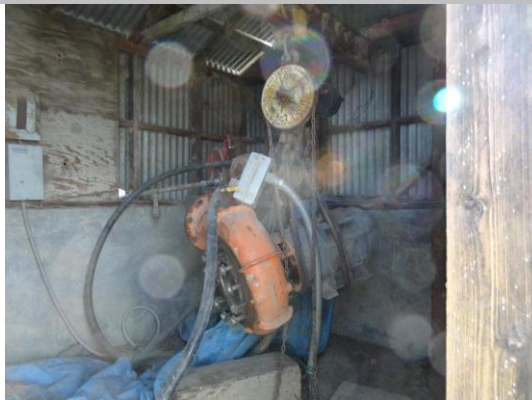
Photo 3 of 3 : UCIP_FA_2019_28903_53160.jpg

WS view: pump removed from pipe and stored in pump house.

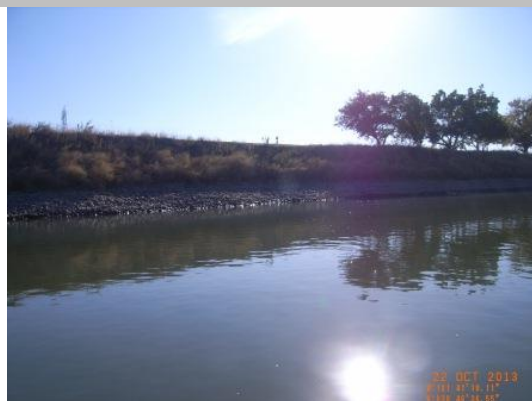
Photo 1 of 1 : FA_2019_RD1500_189_85_20190829_00032.jpg

LM Start	1.34	Rating **	A/W	Issue No.	85
LM End	1.95	Issue Type +	Ma	Location *	WS
Category	Supplemental			GPS Latitude/Longitude	
				Start	End
Item	2017 USACE Erosion Survey			38.770390 °	38.777282 °
				-121.690553 °	-121.685841 °
DWR ID	DWR_RD1500_01_f_2018_85				
Comment Code					
Inspector Comment					
2017 Site ID: SAC 86.3 L Status: Eroding 2017 Field Notes: No observed change.. Site History: 2006 - New erosion upstream, new bank failures near levee but still fairly wide berm in most places. 2008 - Large berm, questionable as to if it should remain in the inventory. 2010 - Minor new erosion, old cobble starting to fail. 2011 - Cobble continues to unravel and additional slumping. 2012 - Minor new erosion at bank mid point. 2013 - Minor new erosion. 2016 - Toe relatively stable. Upper slope is over steepened.

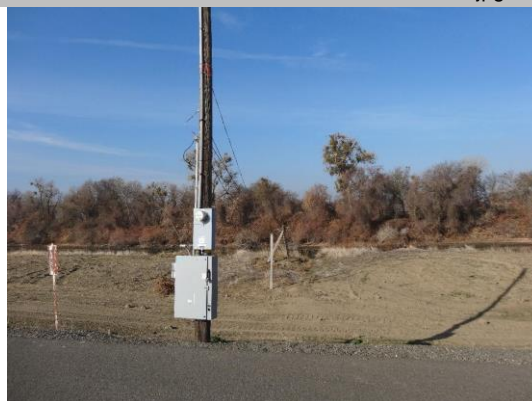
Photo 1 of 3 : UCIP_FA_2019_28204_51875.jpg

Comment Code						
Inspector Comment						
DS_ID:20033 FS_ID:28204 EP_NO: N/A Repair Type: Non-Urgent Crossing Status: Found UCIP Comments: - pump removed- erosion around pump station.- overhead electrical line. FIELD_STRUCT_DESC: 10-inch steel irrigation discharge pipe through the levee, 10 feet below the crown. Pump and gate valve on the riverbank. Service pole and switch panel on the waterside (WS) shoulder. Pipe crosses irrigation ditch and discharges into a steel distribution box in the field. (10-inch steel irrigation discharge pipe through the levee and pump on the riverbank authorized under Automatic Board Order (ABO) issued as Permit No. 10043, 1974 - Leo Giovanetti). [Additional Reference(s): DWR Levee Log, 2005. USACE Sacramento O&M Manual 128, March 1960, (HLM 1.63)]. FS Date: 1/9/2014

WS view: Service pole with control panel on levee shoulder.

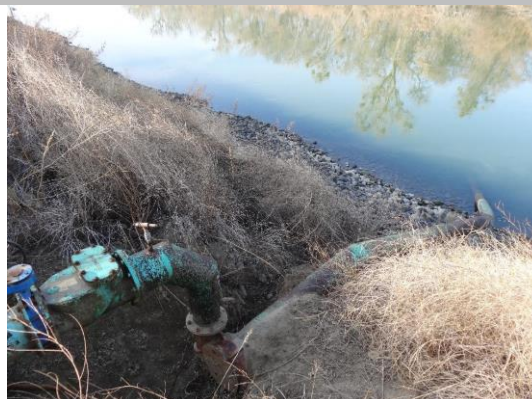
Photo 2 of 3 : UCIP_FA_2019_28204_51874.jpg

WS view: pump (removed) and inlet pipe on river bank.

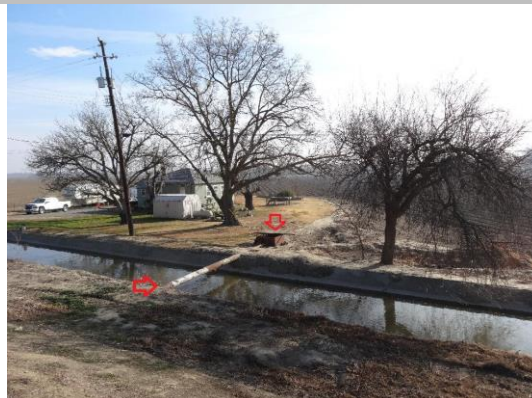
Photo 3 of 3 : UCIP_FA_2019_28204_51873.jpg

Comment Code						
Inspector Comment						
DS_ID:20033 FS_ID:28204 EP_NO: N/A Repair Type: Non-Urgent Crossing Status: Found UCIP Comments: - pump removed- erosion around pump station.- overhead electrical line. FIELD_STRUCT_DESC: 10-inch steel irrigation discharge pipe through the levee, 10 feet below the crown. Pump and gate valve on the riverbank. Service pole and switch panel on the waterside (WS) shoulder. Pipe crosses irrigation ditch and discharges into a steel distribution box in the field. (10-inch steel irrigation discharge pipe through the levee and pump on the riverbank authorized under Automatic Board Order (ABO) issued as Permit No. 10043, 1974 - Leo Giovanetti). [Additional Reference(s): DWR Levee Log, 2005. USACE Sacramento O&M Manual 128, March 1960, (HLM 1.63)]. FS Date: 1/9/2014

LS view: pipe crosses irrigation ditch. Steel distribution box across irrigation ditch.

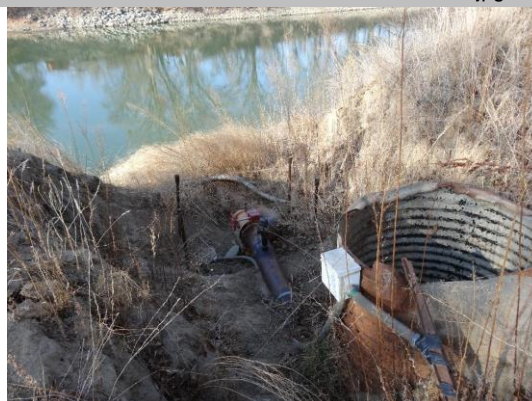
Photo 1 of 3 : UCIP_FA_2019_28263_51965.jpg

Comment Code						
Inspector Comment						
DS_ID:20034 FS_ID:28263 EP_NO: 16146 Repair Type: Non-Urgent Crossing Status: Found UCIP Comments: - pump removed- overhead powerline- pile structure abandoned- levee slope erosion due to leaky siphon breaker on landside. FIELD_STRUCT_DESC: *REPLACEMENT CROSSING* 12-inch steel irrigation discharge pipe through the levee, 12 feet below the crown. Pump mounted on the riverbank. Butterfly valve on the waterside (WS). Power pole with one anchor on the WS slope. Pipe discharges into a 5-foot by 5-foot damaged concrete distribution box across the irrigation ditch on the landside (LS). Electrical conduit through the levee. (Cat. I - Furlan). (Abandonment-in-place of an existing pipe and replacement of approximately 70 feet of 12-inch irrigation discharge pipe authorized under Permit No. 16146, 1993 - Antonio Furlan and Joe Schreiner). [Additional Reference(s): DWR Levee Log, 2005. USACE Sacramento O&M Manual 128, March 1960, (HLM 1.96)]. FS Date: 1/9/2014

WS view: Pump (removed and plywood plated), pipe, and gate valve in CMP riser on river bank.

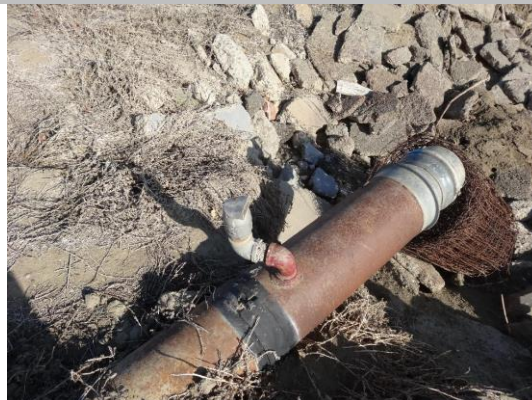
Photo 3 of 3 : UCIP_FA_2019_28264_51969.jpg

Comment Code						
Inspector Comment						
DS_ID:20035 FS_ID:28264 EP_NO: 10029 Repair Type: Non-Urgent Crossing Status: Found UCIP Comments: - pump removed- outlet plugged- looks abandoned. Found abandoned pipe parts on levee slope and berm.- overhead powerline FIELD_STRUCT_DESC: *ABANDONED* 12-inch steel irrigation discharge pipe through the levee, 11 feet below the crown. Two metal cutoff walls installed. Pumps on the riverbank during irrigation season. Gate valve at the waterside (WS) toe. Pipe discharges into a 2.5-foot by 2.5-foot concrete distribution box on the landside (LS) of the irrigation ditch. (Retention of a 12-inch steel irrigation discharge pipe through the levee and pumps on the riverbank during irrigation season authorized under Automatic Board Order (ABO) issued as Permit No. 10029, 1974 - Merle Anderson). [Additional Reference(s): DWR Levee Log, 2005. USACE Sacramento O&M Manual 128, March 1960, (HLM 2.40)]. FS Date: 1/9/2014

LS view: plugged discharge pipe with air vent across irrigation ditch on landside.

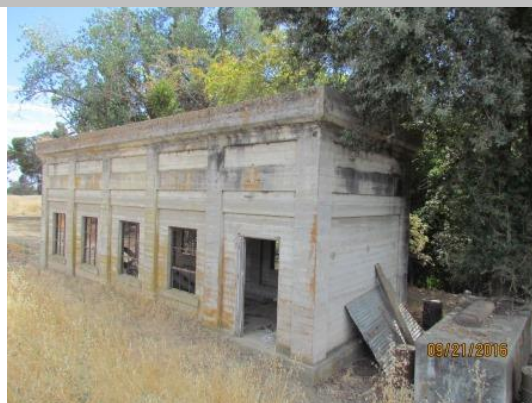
Photo 1 of 1 : FA_2019_RD1500_189_131_20190829_00063.jpg

LM Start	3.69	Rating **	M	Issue No.	131
LM End	3.69	Issue Type +	En	Location *	WS
Category	Earthen Levee			GPS Latitude/Longitude	
				Start	End
Item	Encroachments			38.797152 °	38.797152 °
				-121.691238 °	-121.691238 °
DWR ID	DWR_RD1500_01_f_2016_131				
Comment Code					
BU : Building					
Inspector Comment					
There is an abandoned building at this location.

Abandoned building at waterward toe of the levee. Fall 2016.

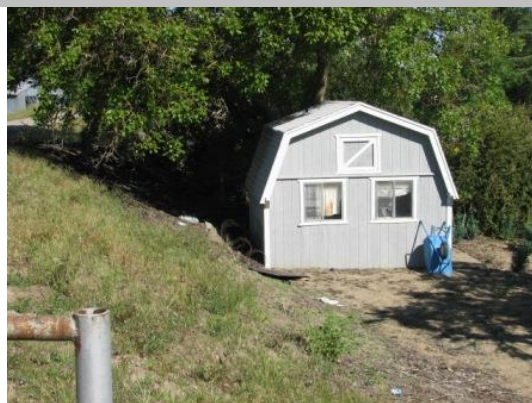
Photo 1 of 2 : FA_2019_RD1500_189_7_20190829_00002.jpg

A small building is encroaching into the landside levee toe.

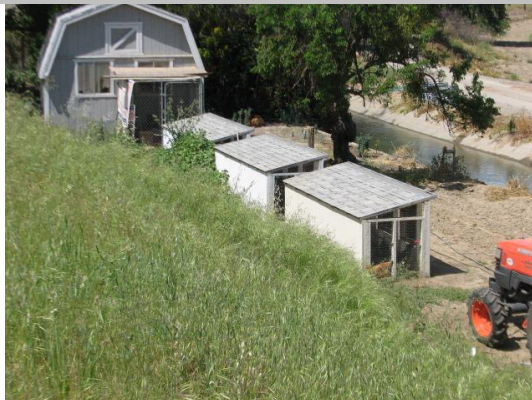
Photo 2 of 2 : FA_2019_RD1500_189_7_20190829_00003.jpg

Chicken coupes have been added along the toe of the levee. Spring

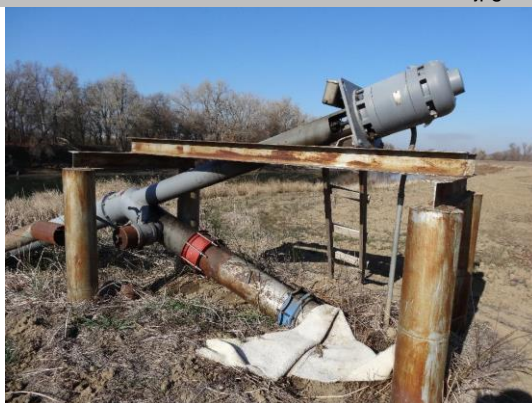
Photo 1 of 3 : UCIP_FA_2019_28272_52012.jpg

Comment Code						
Inspector Comment						
DS_ID:20037 FS_ID:28272 EP_NO: 3638 Repair Type: Non-Urgent Crossing Status: Found UCIP Comments: - No protection for pressure breaker. FIELD_STRUCT_DESC: 12-inch steel irrigation discharge pipe through the levee, 2.4 feet below the crown. Slant pump on the berm. Siphon breaker on the landside (LS) slope. Service pole at the LS toe. Pipe discharges into a 36-inch concrete standpipe on the LS. (Installation, maintenance, and operation of an inclined pump and an existing pipe to remain through the levee authorized under Permit No. 3638, 1961 - James F. Waters). [Additional Reference(s): DWR Levee Log, 2005. USACE Sacramento O&M Manual 128, March 1960, (HLM 4.04)]. FS Date: 1/9/2014

WS view: slant pump on steel frame on levee berm.

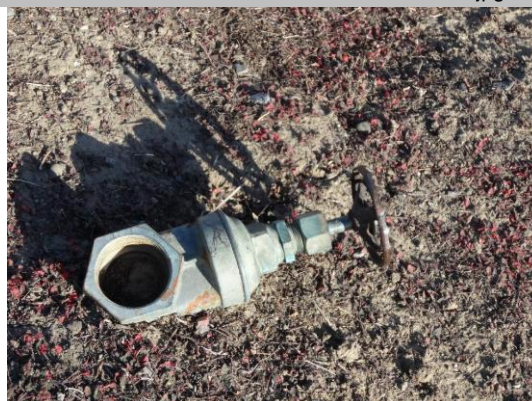
Photo 2 of 3 : UCIP_FA_2019_28272_52011.jpg

Comment Code						
Inspector Comment						
DS_ID:20037						
FS_ID:28272						
EP_NO: 3638						
Repair Type: Non-Urgent						
Crossing Status: Found						
UCIP Comments: - No protection for pressure breaker.						
FIELD_STRUCT_DESC: 12-inch steel irrigation discharge pipe through the levee, 2.4 feet below the crown. Slant pump on the berm. Siphon breaker on the landside (LS) slope. Service pole at the LS toe. Pipe discharges into a 36-inch concrete standpipe on the LS. (Installation, maintenance, and operation of an inclined pump and an existing pipe to remain through the levee authorized under Permit No. 3638, 1961 - James F. Waters). [Additional Reference(s): DWR Levee Log, 2005. USACE Sacramento O&M Manual 128, March 1960, (HLM 4.04)].						
FS Date: 1/9/2014

LS view: pressure breaker without protection on levee slope.

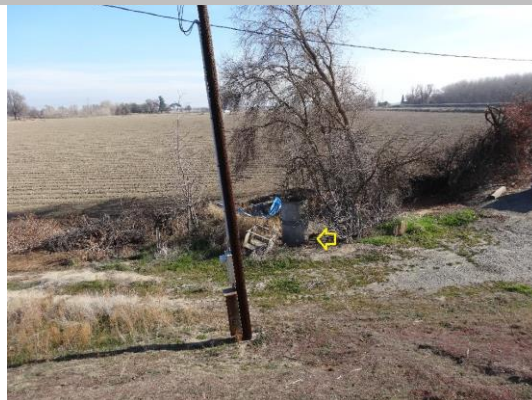
Photo 3 of 3 : UCIP_FA_2019_28272_52013.jpg

LS view: power pole and concrete standpipe on levee toe.

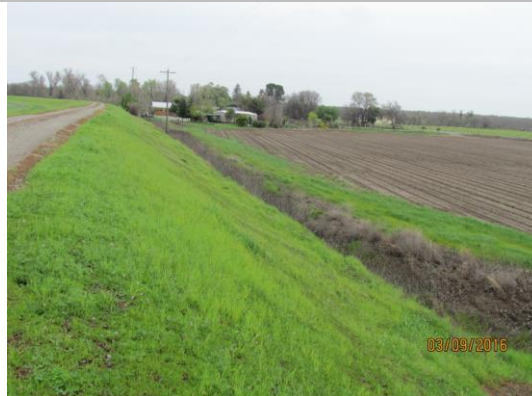
Photo 1 of 1 : FA_2019_RD1500_189_54_20190829_00022.jpg

LM Start	4.02	Rating **	M	Issue No.	54
LM End	4.12	Issue Type +	En	Location *	LS
Category	Earthen Levee			GPS Latitude/Longitude	
				Start	End
Item	Encroachments			38.798526 °	38.800063 °
				-121.696326 °	-121.696622 °
DWR ID	DWR_RD1500_01_s_2012_54				
Comment Code					
DT : Ditch					
Inspector Comment					
A ditch runs along the toe of the levee.

View of the ditch on the landward side of the levee looking upstream. Spring 2016.

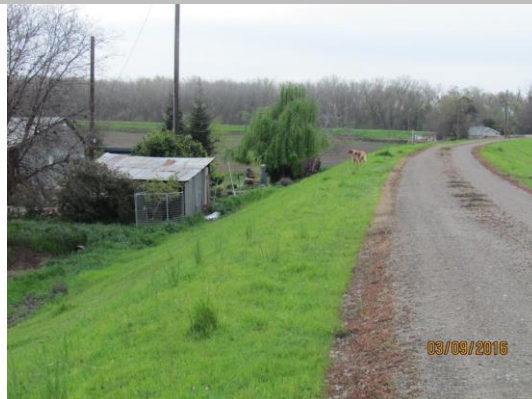
Photo 1 of 1 : FA_2019_RD1500_189_11_20190829_00004.jpg

View of the equipment shed on the landward side of the levee looking downstream. Spring 2016.

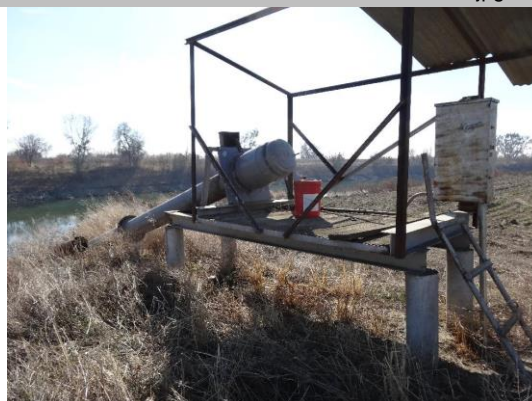
Photo 1 of 3 : UCIP_FA_2019_28912_53181.jpg

Comment Code						
Inspector Comment						
DS_ID:20040 FS_ID:28912 EP_NO: 5031 Repair Type: Non-Urgent Crossing Status: Found UCIP Comments: New butterfly valve in CMP riser on waterside slope. New pipe and pump.Needs cleaning and clearing of siphon breaker in CMP on landside.An abandoned 5x5 foot concrete distribution box on landside. Abandoned pipe found on both sides of the levee. FIELD_STRUCT_DESC: 12-inch steel irrigation discharge pipe through the levee at a slight angle, 4.2 feet below the crown. 2-inch conduit through the levee, 2 feet below the crown. Slant pump on a steel platform on the berm. (Slant pump authorized under Permit No. 5031, 1965 - Gladys Johnston and Helen Dixon). Pipe discharges into an irrigation ditch and an abandoned 5-foot by 5-foot concrete distribution box on the landside. (Pipe originally installed in 1950. 12-inch centrifugal irrigation pump and 14-inch, 12-gage welded steel pipe through the levee authorized under Permit No. 1466, 1950 - Estate of Caroline L. Knox. Pipe reinstalled by USACE in 1958). [Additional Reference(s): DWR Levee Log, 2005. USACE Sacramento O&M Manual 128, March 1960, (HLM 4.71)]. FS Date: 1/9/2014

WS view: slant pump and switch panel in shed on levee berm.

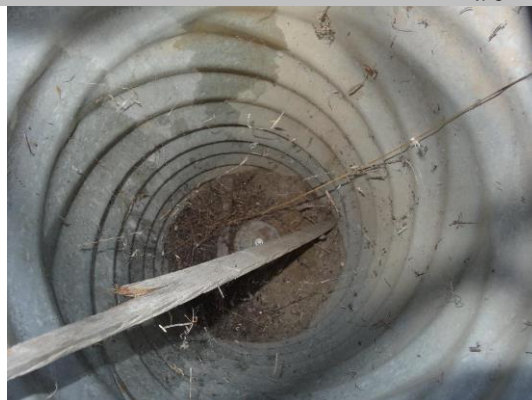
Photo 2 of 3 : UCIP_FA_2019_28912_53180.jpg

LS view: obstructed siphon breaker in CMP riser.

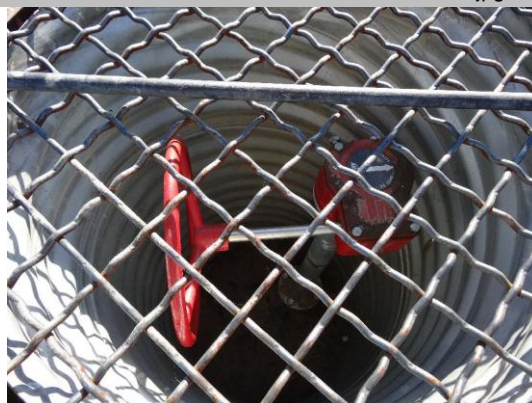
Photo 3 of 3 : UCIP_FA_2019_28912_53179.jpg

Comment Code					
Inspector Comment					
DS_ID:20040 FS_ID:28912 EP_NO: 5031 Repair Type: Non-Urgent Crossing Status: Found UCIP Comments: New butterfly valve in CMP riser on waterside slope. New pipe and pump. Needs cleaning and clearing of siphon breaker in CMP on landside. An abandoned 5x5 foot concrete distribution box on landside. Abandoned pipe found on both sides of the levee. FIELD_STRUCT_DESC: 12-inch steel irrigation discharge pipe through the levee at a slight angle, 4.2 feet below the crown. 2-inch conduit through the levee, 2 feet below the crown. Slant pump on a steel platform on the berm. (Slant pump authorized under Permit No. 5031, 1965 - Gladys Johnston and Helen Dixon). Pipe discharges into an irrigation ditch and an abandoned 5-foot by 5-foot concrete distribution box on the landside. (Pipe originally installed in 1950. 12-inch centrifugal irrigation pump and 14-inch, 12-gage welded steel pipe through the levee authorized under Permit No. 1466, 1950 - Estate of Caroline L. Knox. Pipe reinstalled by USACE in 1958). [Additional Reference(s): DWR Levee Log, 2005. USACE Sacramento O&M Manual 128, March 1960, (HLM 4.71)]. FS Date: 1/9/2014

WS view: new butterfly valve in CMP on levee shoulder.

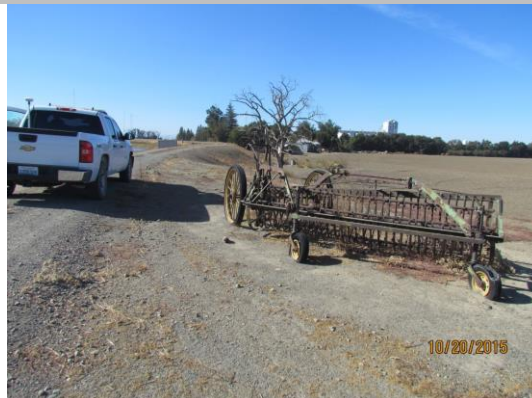
Photo 1 of 1 : FA_2019_RD1500_189_108_20190829_00047.jpg

LM Start	5.14	Rating **	M	Issue No.	108
LM End	5.14	Issue Type +	En	Location *	LS
Category	Earthen Levee			GPS Latitude/Longitude	
				Start	End
Item	Encroachments			38.801962 °	38.801962 °
				-121.712118 °	-121.712118 °
DWR ID	DWR_RD1500_01_f_2015_108				
Comment Code					
EQ : Equipment					
Inspector Comment

View of the equipment on the landward side of the levee looking upstream. Fall 2015.

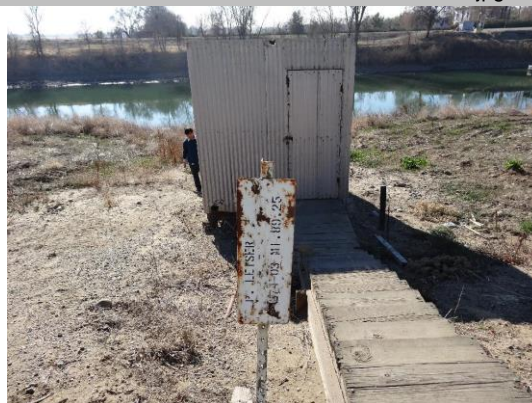
Photo 1 of 3 : UCIP_FA_2019_28913_53184.jpg

Comment Code						
Inspector Comment						
DS_ID:20041 FS_ID:28913 EP_NO: 10056 Repair Type: Non-Urgent Crossing Status: Found UCIP Comments: Depression on landside levee slope around siphon breaker due to leakage.Siphon breaker needs protection. FIELD_STRUCT_DESC: 18-inch steel irrigation discharge pipe through the levee, 4 feet below the crown. 1.5-inch conduit through the levee, 20 feet below the crown. Slant pump in a corrugated metal pump house on the waterside (WS). Wooden steps on the WS slope. Siphon breaker on the landside (LS) slope. 5-foot by 5-foot concrete distribution box at the LS toe. (18-inch steel irrigation discharge pipe and all other elements of this irrigation structure retained under Automatic Board Order (ABO) issued as Permit No. 10056, 1974 - Philip Leiser). [Additional Reference(s): DWR Levee Log, 2005. USACE Sacramento O&M Manual 128, March 1960, (HLM 5.23)]. FS Date: 1/9/2014

WS view: wooden steps to pump house on levee berm.

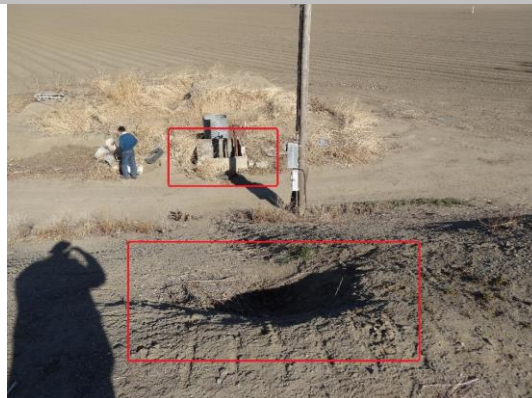
Photo 2 of 3 : UCIP_FA_2019_28913_53183.jpg

Comment Code						
Inspector Comment						
DS_ID:20041 FS_ID:28913 EP_NO: 10056 Repair Type: Non-Urgent Crossing Status: Found UCIP Comments: Depression on landside levee slope around siphon breaker due to leakage.Siphon breaker needs protection. FIELD_STRUCT_DESC: 18-inch steel irrigation discharge pipe through the levee, 4 feet below the crown. 1.5-inch conduit through the levee, 20 feet below the crown. Slant pump in a corrugated metal pump house on the waterside (WS). Wooden steps on the WS slope. Siphon breaker on the landside (LS) slope. 5-foot by 5-foot concrete distribution box at the LS toe. (18-inch steel irrigation discharge pipe and all other elements of this irrigation structure retained under Automatic Board Order (ABO) issued as Permit No. 10056, 1974 - Philip Leiser). [Additional Reference(s): DWR Levee Log, 2005. USACE Sacramento O&M Manual 128, March 1960, (HLM 5.23)]. FS Date: 1/9/2014

LS view: depression on landside levee slope around siphon breaker due to leakage. Concrete distribution box (top) on levee toe.

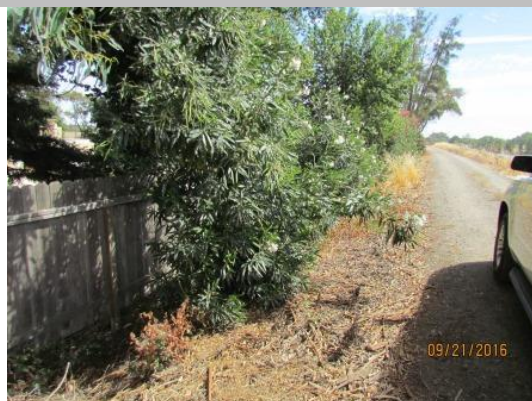
Photo 1 of 1 : FA_2019_RD1500_189_125_20190829_00062.jpg

LM Start	5.32	Rating **	U	Issue No.	125
LM End	5.35	Issue Type +	En	Location *	LS
Category	Earthen Levee			GPS Latitude/Longitude	
				Start	End
Item	Encroachments			38.803181 °	38.803344 °
				-121.715141 °	-121.715616 °
DWR ID	DWR_RD1500_01_f_2016_125				
Comment Code					
FE : Fence					
Inspector Comment

View of fence and vegetation on LS slope. Fall 2016.

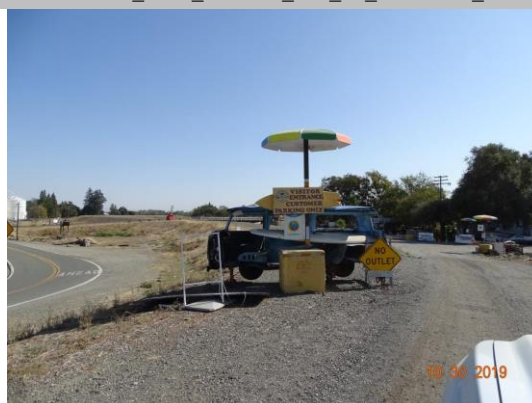
Photo 1 of 2 : FA_2019_RD1500_189_52_20191031_00214.jpg

LM Start	5.61	Rating **	U	Issue No.	52
LM End	5.69	Issue Type +	En	Location *	WS
Category	Earthen Levee			GPS Latitude/Longitude	
				Start	End
Item	Encroachments			38.803067 °	38.803238 °
				-121.720270 °	-121.721847 °
DWR ID	DWR_RD1500_01_s_2012_52				
Comment Code					
EQ : Equipment					
Inspector Comment					
Sting Rayz Beach Boardwalk Marina on the waterside berm should move equipment stored on levee toe and crown.

View of equipment on the crown. Fall 2019.

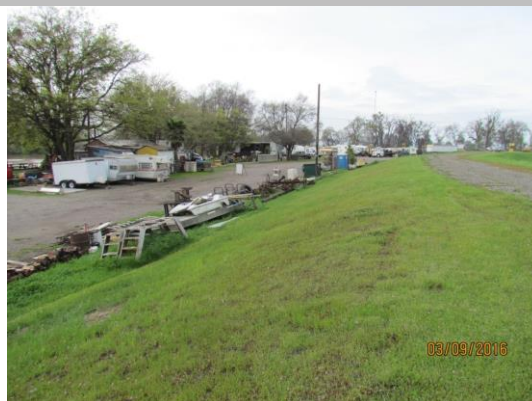
Photo 2 of 2 : FA_2019_RD1500_189_52_20190829_00021.jpg

View of equipment on waterside levee toe looking upstream. Spring 2016.

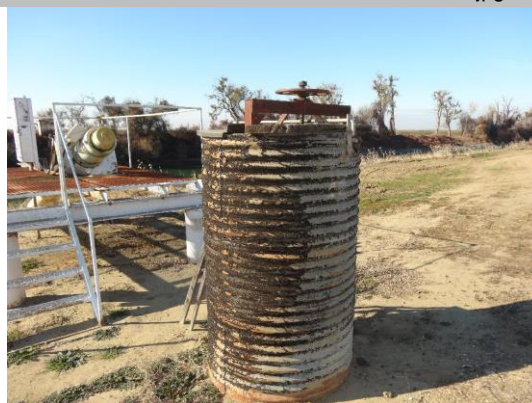
Photo 1 of 2 : UCIP_FA_2019_28286_52059.jpg

Comment Code					
Inspector Comment					
DS_ID:20044 FS_ID:28286 EP_NO: 10074 Repair Type: Non-Urgent Crossing Status: Found UCIP Comments: Not found- 36-inch concrete standpipe on landside. 2-inch conduit through the levee.Pipe description does not match with field observaion. It needs review and more info from LMA.A capped pipe, air vent, and butterfly valve found on landside toe. But, it is not clear whether these belongs to this crossing. FIELD_STRUCT_DESC: 30-inch steel irrigation discharge pipe and electrical conduit through the levee, 13 feet below the crown. Slide gate in a 42-inch corrugated metal pipe (CMP) riser on the berm. Slant pump on steel pump platform on the berm. Installed by USACE in 1959. (30-inch steel irrigation discharge pipe and all other appurtenances retained under Automatic Board Order (ABO) issued as Permit No. 10074, 1974 - T. I. and T. Company). [Additional Reference(s): DWR Levee Log, 2005. USACE Sacramento O&M Manual 128, March 1960, (HLM 6.53)]. FS Date: 1/9/2014

WS view: CMP riser with slide gate and slant pump on steel platform on levee berm.

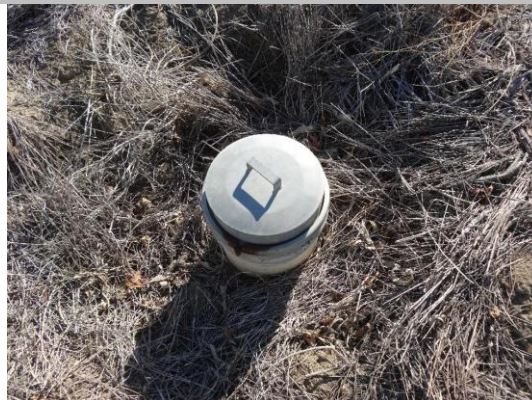
Photo 2 of 2 : UCIP_FA_2019_28286_52058.jpg

Comment Code						
Inspector Comment						
DS_ID:20044 FS_ID:28286 EP_NO: 10074 Repair Type: Non-Urgent Crossing Status: Found UCIP Comments: Not found- 36-inch concrete standpipe on landside. 2-inch conduit through the levee.Pipe description does not match with field observaion. It needs review and more info from LMA.A capped pipe, air vent, and butterfly valve found on landside toe. But, it is not clear whether these belongs to this crossing. FIELD_STRUCT_DESC: 30-inch steel irrigation discharge pipe and electrical conduit through the levee, 13 feet below the crown. Slide gate in a 42-inch corrugated metal pipe (CMP) riser on the berm. Slant pump on steel pump platform on the berm. Installed by USACE in 1959. (30-inch steel irrigation discharge pipe and all other appurtenances retained under Automatic Board Order (ABO) issued as Permit No. 10074, 1974 - T. I. and T. Company). [Additional Reference(s): DWR Levee Log, 2005. USACE Sacramento O&M Manual 128, March 1960, (HLM 6.53)]. FS Date: 1/9/2014

LS view: a capped pipe on levee toe. It is not clear whether this pipe is connected to the CMP riser on waterside.

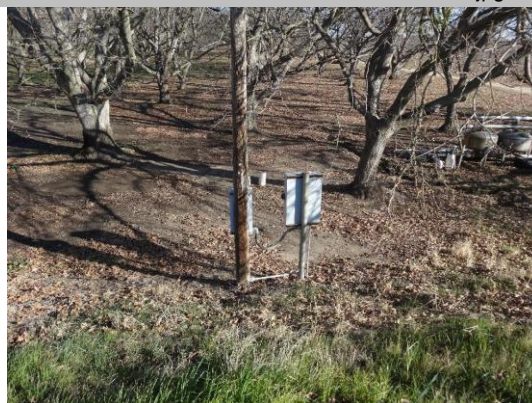
Photo 3 of 3 : UCIP_FA_2019_28923_53200.jpg

Comment Code						
Inspector Comment						
DS_ID:20047 FS_ID:28923 EP_NO: 10048 Repair Type: Non-Urgent Crossing Status: Found UCIP Comments: An abandoned pipe. Highly deteriorated pipe on river bank.Needs proper abandonment.Not found- Siphon breaker at landward levee toe. FIELD_STRUCT_DESC: *ABANDONED* 10-inch steel irrigation discharge pipe and a 1-inch conduit through the levee, 4.5 feet below the crown. Pump in a metal shed on the riverbank. Gate valve on the waterside (WS) end. Service pole and 24-inch concrete standpipe at the landside (LS) toe. Installed by USACE in 1958. (10-inch steel irrigation discharge pipe through the levee and all other appurtenances retained under Automatic Board Order (ABO) issued as Permit No. 10048, 1974 - Virgil J. King) [Additional Reference(s): DWR Levee Log, 2005. USACE Sacramento O&M Manual 128, March 1960, (HLM 7.22)]. FS Date: 1/9/2014

LS view: service pole and switch board on levee toe. No other appurtenances found on landside.

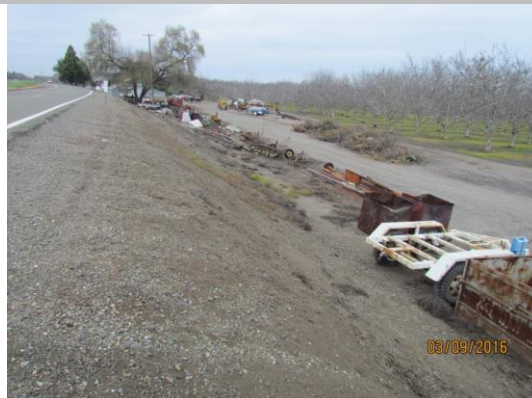
Photo 1 of 1 : FA_2019_RD1500_189_16_20190829_00005.jpg

LM Start	7.49	Rating **	M	Issue No.	16
LM End	7.49	Issue Type +	En	Location *	LS
Category	Earthen Levee			GPS Latitude/Longitude	
				Start	End
Item	Encroachments			38.828944 °	38.828944 °
				-121.724329 °	-121.724329 °
DWR ID	DWR_RD1500_01_f_2017_16				
Comment Code					
EQ : Equipment					
Inspector Comment

View of the equipment along the levee toe on the landward side of the levee looking upstream. Spring 2016.

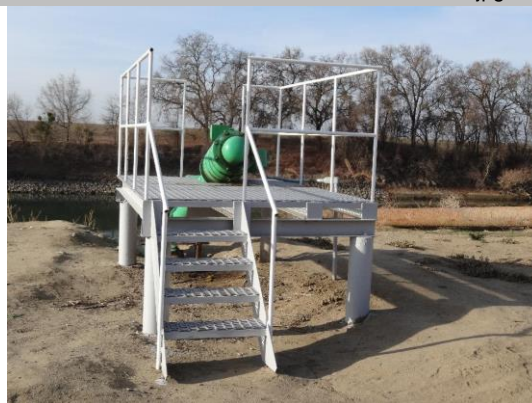
Photo 1 of 3 : UCIP_FA_2019_50199_53204.jpg

Comment Code						
Inspector Comment						
DS_ID:20049 FS_ID:50199 EP_NO: 8147 Repair Type: Non-Urgent Crossing Status: Found UCIP Comments: 08/29/2016: New pumps installed at LS toe ditch, could not find permit for this work. No signs of leakage or excessive vegetation growth in alignment with the pipe. Riser silted in; recommend installing a lid. Crossing has been downgraded from Urgent to Non-Urgent. (K. Fazel - UCIP)01/10/2014:Not found- slide gate in 48-inch corrugated metal riser at waterside toe.Repair works under way. Contact LMA for repair works information.Sign of leaky pipe and siphon breaker. This needs detailed investigation. (P. Amatya - DWR) FIELD_STRUCT_DESC: 12-inch steel irrigation discharge pipe through the levee, 4.8 feet below the crown. Slant pump mounted on a steel structure at the riverbank. 4-foot by 4-foot concrete distribution box at the landside (LS) toe with newly installed pumps with shutoff valves. (Replacement of a discharge pipe through the levee with a new 12-inch steel discharge pipe authorized under Permit No. 8147, 1972 - J. A. Driver). [Additional Reference(s): DWR Levee Log, 2005. USACE Sacramento O&M Manual 128, March 1960, (HLM 7.79)]. FS Date: 8/29/2016

WS view: slant pump on steel platform on end of berm.

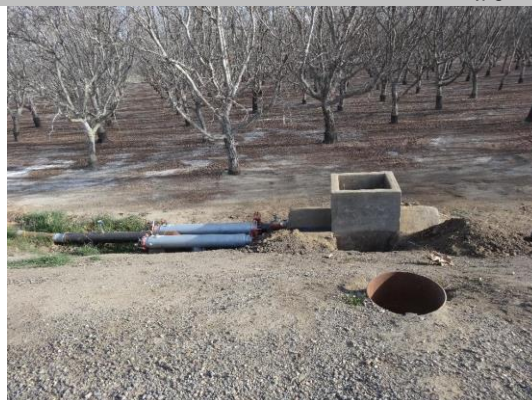
Photo 3 of 3 : UCIP_FA_2019_50199_53207.jpg

Comment Code						
Inspector Comment						
DS_ID:20049 FS_ID:50199 EP_NO: 8147 Repair Type: Non-Urgent Crossing Status: Found UCIP Comments: 08/29/2016: New pumps installed at LS toe ditch, could not find permit for this work. No signs of leakage or excessive vegetation growth in alignment with the pipe. Riser silted in; recommend installing a lid. Crossing has been downgraded from Urgent to Non-Urgent. (K. Fazel - UCIP)01/10/2014:Not found- slide gate in 48-inch corrugated metal riser at waterside toe.Repair works under way. Contact LMA for repair works information.Sign of leaky pipe and siphon breaker. This needs detailed investigation. (P. Amatya - DWR) FIELD_STRUCT_DESC: 12-inch steel irrigation discharge pipe through the levee, 4.8 feet below the crown. Slant pump mounted on a steel structure at the riverbank. 4-foot by 4-foot concrete distribution box at the landside (LS) toe with newly installed pumps with shutoff valves. (Replacement of a discharge pipe through the levee with a new 12-inch steel discharge pipe authorized under Permit No. 8147, 1972 - J. A. Driver). [Additional Reference(s): DWR Levee Log, 2005. USACE Sacramento O&M Manual 128, March 1960, (HLM 7.79)]. FS Date: 8/29/2016

LS view: steel riser with siphon breaker (bottom) and concrete distribution box on levee toe (top).

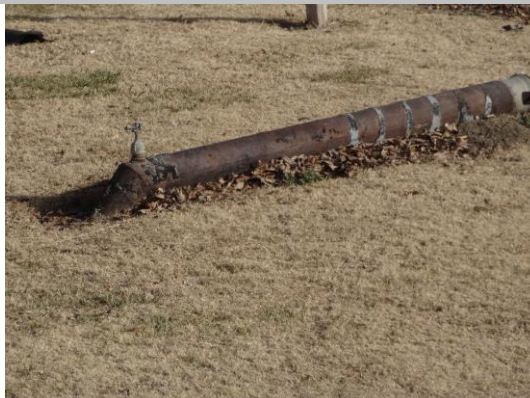
Photo 3 of 3 : UCIP_FA_2019_28323_52123.jpg

Item	DRAFT DWR UCIP Field Study		38.834260 °	38.834260 °								
			-121.729566 °	-121.729566 °								
DWR ID	20051											
Comment Code												
Inspector Comment												
DS_ID:20051 FS_ID:28323 EP_NO: 13882 Repair Type: Non-Urgent Crossing Status: Found UCIP Comments: Power pole on landside. 2-inch conduit through the levee. Service box on waterside. Concrete pad on waterside. Not found- Concrete distribution box on landward side; not found- gate valve on waterside. Need proper abandonment. Pipe visible on river bank, waterside levee slope and landside field. FIELD_STRUCT_DESC: *ABANDONED* 6-inch steel irrigation discharge pipe through the levee, 4.9 feet below the crown. 12-inch steel irrigation discharge pipe through the levee, 5 feet below the crown. 1.5-inch electrical conduit through the levee, 4 feet below the crown. Pump at the riverbank. Pump switch and gate valve on the waterside (WS) slope. Meter pole at the landside (LS) toe. Concrete distribution box on the LS. Installed by USACE in 1959. (6-inch steel irrigation discharge pipe through the levee and all other appurtenances retained under Automatic Board Order (ABO) issued as Permit No. 10062, 1974 - Pauline Moroni. Installation of a 12-inch steel pipe through the levee authorized under Permit No. 13882, 1984 - Ted A. Moroni). [Additional Reference(s): DWR Levee Log, 2005. USACE Sacramento O&M Manual 128, March 1960, (HLM 8.04)]. FS Date: 1/10/2014

LS view: outlet steel pipe across the residential road off the levee toe on field.

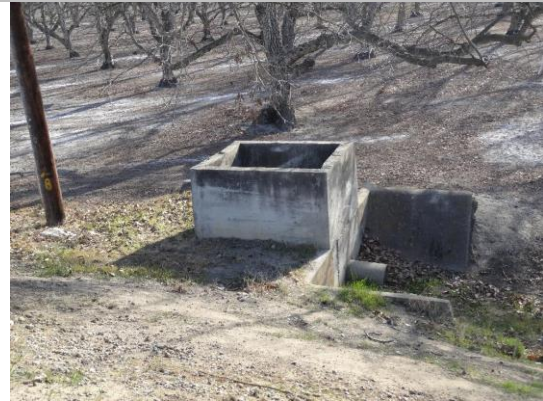
Photo 3 of 3 : UCIP_FA_2019_28324_52129.jpg

Comment Code						
Inspector Comment						
DS_ID:20053 FS_ID:28324 EP_NO: 10064 Repair Type: Non-Urgent Crossing Status: Found UCIP Comments: Looks abandoned as service pole not found.May need proper abandonment. FIELD_STRUCT_DESC: 24-inch by 24-inch concrete box irrigation discharge culvert through the levee, 13 feet below the crown. Two concrete cutoff walls. Pump on a 6-foot-diameter concrete pump well on the berm. Slide gate in a 42-inch corrugated metal pipe (CMP) riser on the waterside (WS) slope. 4.5-foot by 6-foot concrete distribution box at the landside (LS) toe. Installed by Reclamation District No. 1500 in 1920. Improvements made by USACE in 1955. (24-inch by 24-inch concrete box irrigation discharge culvert through the levee and all other appurtenances retained under Automatic Board Order (ABO) issued as Permit No. 10064, 1974 - Paul Donald Nix). [Additional Reference(s): DWR Levee Log, 2005. USACE Sacramento O&M Manual 128, March 1960, (HLM 8.44), 36-inch pipe referenced]. FS Date: 1/10/2014

LS view: concrete distribution box on levee toe.

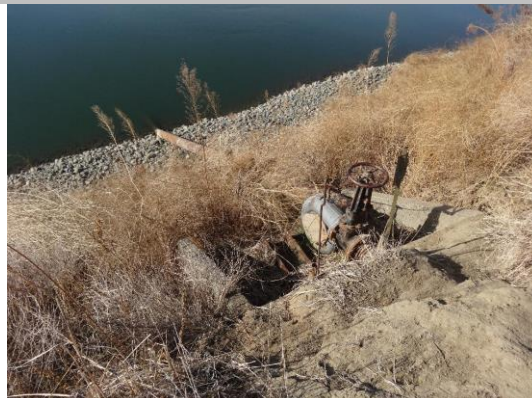
Photo 1 of 3 : UCIP_FA_2019_28343_52145.jpg

Comment Code						
Inspector Comment						
DS_ID:20054 FS_ID:28343 EP_NO: 5518 Repair Type: Non-Urgent Crossing Status: Found UCIP Comments: Not found- siphon breaker on landward shoulder. Pump removed. FIELD_STRUCT_DESC: 10-inch steel irrigation discharge pipe through the levee, 2.5 feet below the crown. Corrugated metal cutoff wall. Pump on concrete platform on the riverbank. Siphon breaker on the landside (LS) shoulder. 1-inch conduit installed in joint trench. Meter pole at the LS toe. Pipe discharges into a 4-foot by 4-foot concrete distribution box on the LS. (Installation of a 10-inch irrigation discharge pipe through the levee with a pump and a discharge box authorized under Permit No. 5518, 1966 - Irving E. Bundock, [RM 92.9]). FS Date: 1/10/2014

WS view: U type concrete headwall, pipe, and pump on river bank.

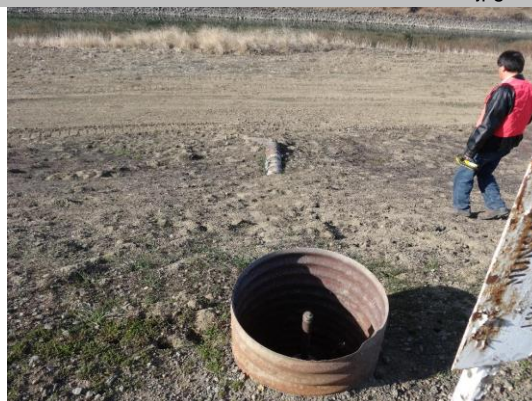
Photo 1 of 3 : UCIP_FA_2019_28363_52167.jpg

Comment Code					
Inspector Comment					
DS_ID:20055 FS_ID:28363 EP_NO: 8503 Repair Type: Non-Urgent Crossing Status: Found UCIP Comments: Looks abandoned. No pump found on WS.New well near landside.May need proper abandonment.Exposed pipe on waterside. Found steel plate closed pipe on landside. FIELD_STRUCT_DESC: *ABANDONED* 12-inch steel irrigation discharge pipe through the levee, 3.8 feet below the crown. Pump on concrete pad with headwall at the riverbank. Siphon breaker in a 24-inch corrugated metal pipe (CMP) riser on the waterside (WS) slope. 1.25-inch conduit through the levee, 3 feet below the crown. Meter pole with switch panel at the landside (LS) toe. Concrete distribution box at the LS toe. (12-inch steel irrigation discharge pipe through the levee and slant pump retained under Permit No. 8503, 1972 - James T. Munson). [Additional Reference(s): DWR Levee Log, 2005. USACE Sacramento O&M Manual 128, March 1960, (HLM 9.04), 10-inch pipe referenced]. FS Date: 1/10/2014

WS view: siphon breaker in CMP riser on levee slope.

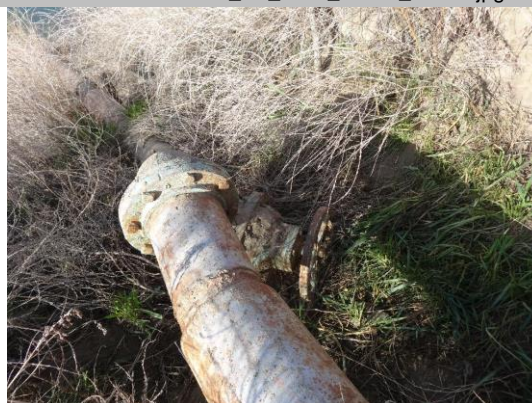
Photo 2 of 3 : UCIP_FA_2019_28363_52166.jpg

WS view: inlet steel pipe with gate valve on river bank.

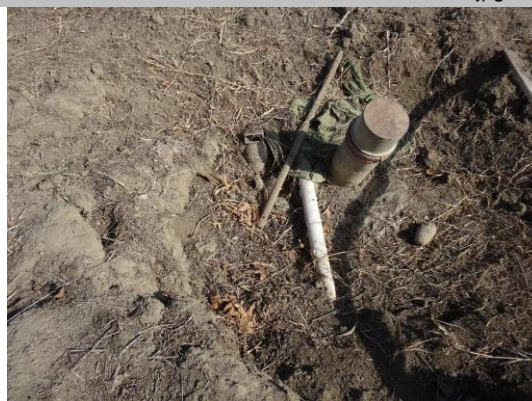
Photo 3 of 3 : UCIP_FA_2019_28364_52173.jpg

Comment Code						
Inspector Comment						
DS_ID:20056 FS_ID:28364 EP_NO: 5598 Repair Type: Non-Urgent Crossing Status: Found UCIP Comments: Not found- Wood headwall 18 ft from landward toe. Not found- Flap gate on landward side.No outlet structure found. Only a capped pipe found, but not sure whether it is connected to the crossing. FIELD_STRUCT_DESC: 12-inch steel irrigation discharge pipe and electrical conduit through the levee, 4.8 feet below the crown. One metal cutoff wall. Slant pump on steel structure on the berm. Siphon breaker in an 8.5-inch steel pipe riser on the landside (LS) shoulder. Meter pole on the LS toe. Wooden headwall with flap gate off the LS toe. Pipe discharges into field. Installed in 1967. (Construction of a pumping plant and installation of a discharge pipe through the levee authorized under Permit No. 5598, 1966 - Arthur C. James Jr. Existing encroachments retained under Permit No. 8505, 1972 - Arthur C. James Jr.). [Additional Reference(s): DWR Levee Log, 2005]. FS Date: 1/10/2014

LS view: capped outlet pipe on levee toe.

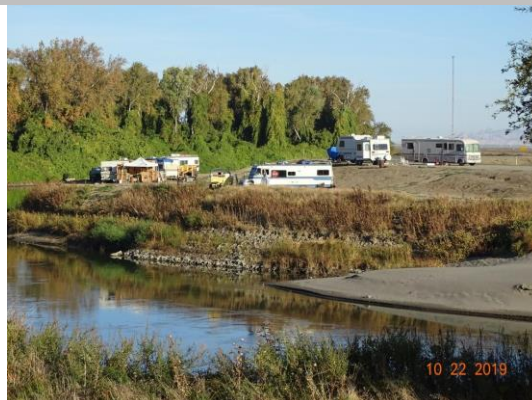
Photo 1 of 3 : FA_2019_RD1500_189_132_20191031_00212.jpg

LM Start	9.26	Rating **	U	Issue No.	132
LM End	9.33	Issue Type +	En	Location *	WS
Category	Earthen Levee			GPS Latitude/Longitude	
				Start	End
Item	Encroachments			38.849032 °	38.849619 °
				-121.725126 °	-121.724161 °
DWR ID	DWR_RD1500_01_f_2018_132				
Comment Code					
UR : Urban					
Inspector Comment					
Multiple trailers and constructed shacks on the waterside berm are taking up long-term residence.

View of trailers on waterside shoulder and berm near Donahue Road.
Fall 2019.

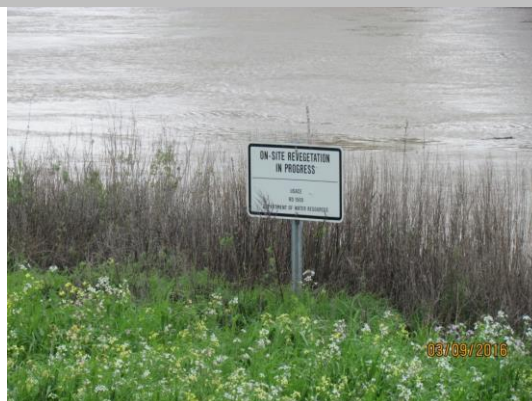
Photo 2 of 2 : FA_2019_RD1500_189_74_20190829_00027.jpg

Sign for the revegetation site by USACE.

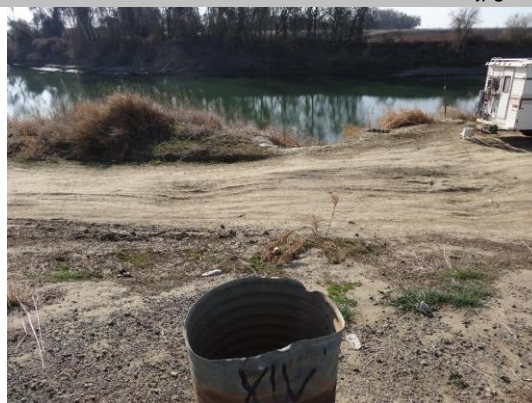
Photo 1 of 3 : UCIP_FA_2019_28365_52182.jpg

Comment Code						
Inspector Comment						
DS_ID:20057 FS_ID:28365 EP_NO: N/A Repair Type: Non-Urgent Crossing Status: Found UCIP Comments: Looks abandoned. Pump has been removed. No outlet pipe found. Not found- Wooden service panel and 3x5 foot concrete distribution box at landward shoulder.May need proper abandonment. FIELD_STRUCT_DESC: 14-inch steel irrigation discharge pipe through the levee, 4.2 feet below the crown. Pump and gate valve on a concrete pump platform on the bank. Siphon breaker in a 24-inch corrugated metal pipe (CMP) riser on the waterside (WS) shoulder. Wooden switch panel and pole on the WS slope. 3-foot by 5-foot concrete distribution box at the landside (LS) toe. (14-inch steel irrigation discharge pipe through the levee, pump, and all other appurtenances retained under Automatic Board Order (ABO) issued as Permit No. 10069, 1974 - Robert Reel). [Additional Reference(s): DWR Levee Log, 2005. USACE Sacramento O&M Manual 128, March 1960, (HLM 9.77)]. FS Date: 1/10/2014

WS view: CMP riser with siphon breaker on levee slope.

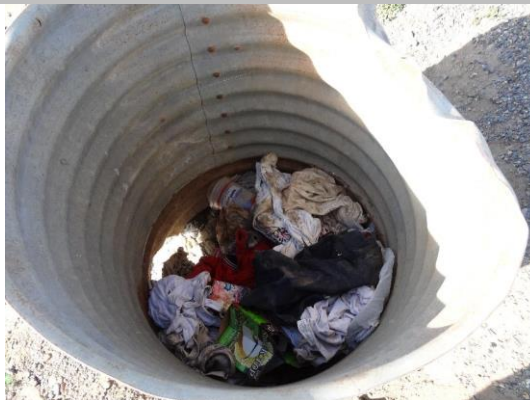
Photo 2 of 3 : UCIP_FA_2019_28365_52180.jpg

WS view: siphon breaker obstructed by dumped-trash in CMP riser.

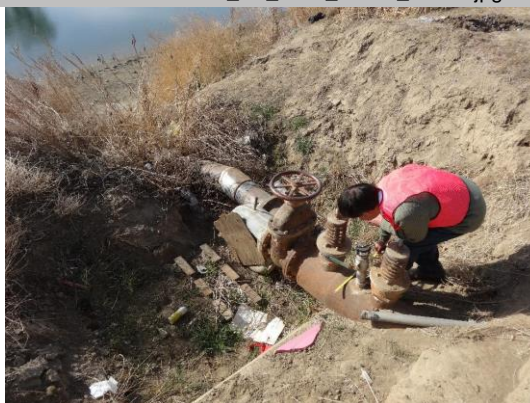
Photo 3 of 3 : UCIP_FA_2019_28365_52179.jpg

LS view: U type concrete headwall, pipe, gate valve, and pump (removed and plugged with plywood) on river bank.

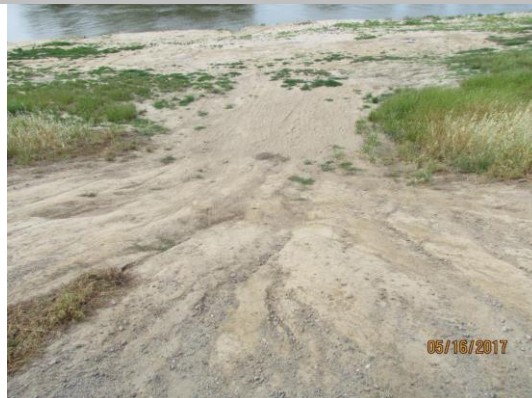
Photo 1 of 1 : FA_2019_RD1500_189_162_20190829_00071.jpg

LM Start	9.71	Rating **	A/W	Issue No.	162
LM End	9.71	Issue Type +	Ma	Location *	WS
Category	Earthen Levee			GPS Latitude/Longitude	
				Start	End
Item	Slope Stability			38.853564 °	38.853564 °
				-121.725379 °	-121.725379 °
DWR ID	DWR_RD1500_01_s_2017_162				
Comment Code					
S3 : Repair the levee slope damaged by vehicle traffic and prevent access where possible.					
Inspector Comment					
The area is heavily accessed by trailer residents and fishermen. Recommend monitoring.

View of slope stability on waterside slope. Spring 2017.

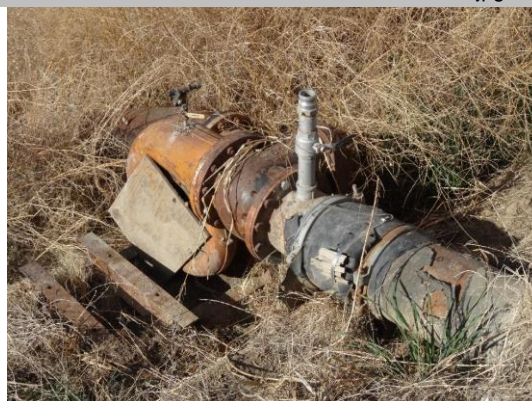
Photo 1 of 3 : UCIP_FA_2019_50069_52188.jpg

Comment Code					
Inspector Comment					
DS_ID:20058 FS_ID:50069 EP_NO: 10068 Repair Type: Non-Urgent Crossing Status: Found UCIP Comments: 01/10/2014Surface erosion along pipe alignment on landside.30-inch concrete pipe in CMP riser on waterside. 30-inch x 24-inch concrete culvert on landside. FIELD_STRUCT_DESC: 24-inch by 30-inch reinforced concrete box irrigation discharge culvert diagonally through the levee, 13 feet below the crown. Two concrete cutoff walls. Slant pump on the riverbank. Slide gate in a 40-inch by 40-inch concrete surge box on the berm. Power pole and switch panel on the waterside (WS) slope. Concrete distribution box at the landside (LS) toe. Installed by Reclamation District No. 1500 in 1920. (24-inch by 30-inch reinforced concrete box irrigation discharge culvert diagonally through the levee, slant pump, and all other appurtenances retained under Automatic Board Order (ABO) issued as Permit No. 10068, 1974 - Cecil Reel). [Additional Reference(s): DWR Levee Log, 2005. USACE Sacramento O&M Manual 128, March 1960, (HLM 10.22)]. FS Date: 1/10/2014

WS view: pipe and pump with appurtenances on river bank. Pump removed and plugged with plywood.

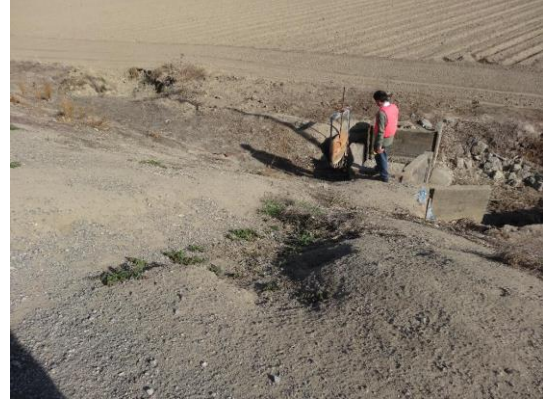
Photo 2 of 3 : UCIP_FA_2019_50069_52189.jpg

LS view: surface erosion along pipe alignment on landside.

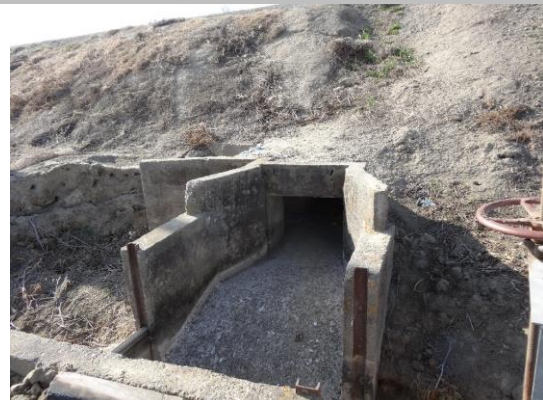
Photo 3 of 3 : UCIP_FA_2019_50069_52192.jpg

LS view: outlet of concrete box culvert on levee toe.

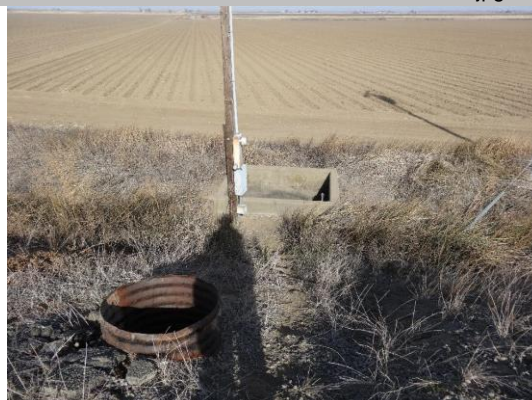
Photo 2 of 3 : UCIP_FA_2019_28925_53209.jpg

LS view: siphon breaker in CMP riser (bottom) on levee slope and concrete distribution box (top) on levee toe.

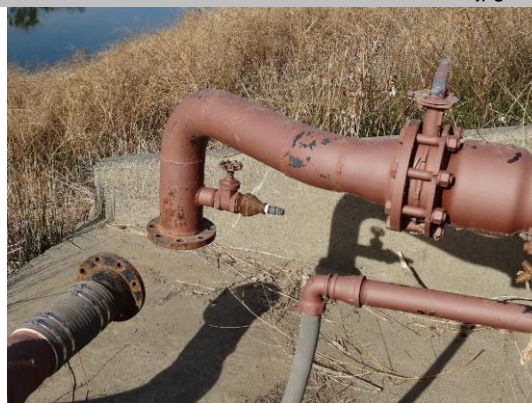
Photo 1 of 3 : UCIP_FA_2019_50198_52220.jpg

Comment Code						
Inspector Comment						
DS_ID:20061 FS_ID:50198 EP_NO: 10041 Repair Type: Non-Urgent Crossing Status: Found UCIP Comments: 08/29/2016 Depressions cited previously are a make-shift staircase and not an indication of a problem with pipe. Pipe partiallay exposed on LS slope which should be backfilled. Crossing has been downgraded from Urgent to Non-Urgent. (K. Fazel - UCIP)01/10/2014 Depressions on both sides of the levee slope. It needs more investigation.Pump removed. (P. Amatya - DWR) FIELD_STRUCT_DESC: 8-inch steel irrigation discharge pipe through the levee, 4 feet below the crown. One corrugated metal cutoff wall. Pump and gate valve on a concrete pump platform on the riverbank. Corrugated metal switch house on the waterside (WS) slope. Meter pole on the WS shoulder. 8-foot by 6-foot, inside dimensions, concrete distribution box on the landside (LS). Overhead power line crosses the levee. Pole at the LS toe. Installed by USACE in 1952. (8-inch steel irrigation discharge pipe through the levee, pump, and all other appurtenances retained under Automatic Board Order (ABO) issued as Permit No. 10041, 1974 - William J. Duffy Jr.) [Additional Reference(s): DWR Levee Log, 2005. USACE Sacramento O&M Manual 128, March 1960, (HLM 11.57)]. FS Date: 8/29/2016

WS view: pipe, pump (removed), headwall, and appurtenances on river bank.

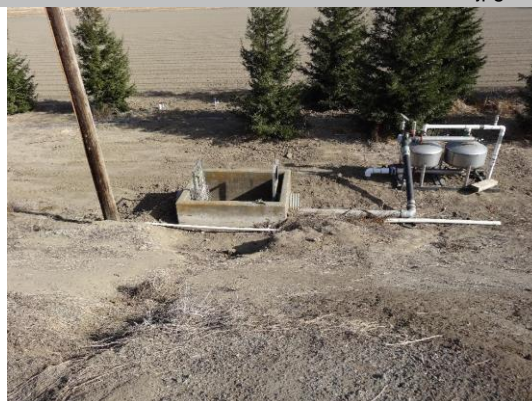
Photo 2 of 3 : UCIP_FA_2019_50198_52219.jpg

LS view: depressions along the pipe alignment on levee slope. It needs detailed investigation.

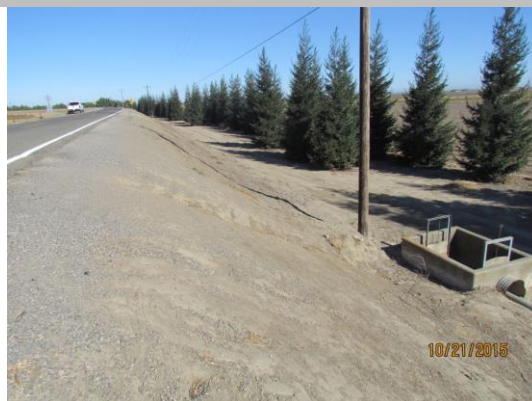
Photo 1 of 3 : FA_2019_RD1500_189_114_20190829_00049.jpg

LM Start	11.45	Rating **	M	Issue No.	114
LM End	11.45	Issue Type +	En	Location *	LS
Category	Earthen Levee			GPS Latitude/Longitude	
				Start	End
Item	Encroachments			38.868577 °	38.868577 °
				-121.746487 °	-121.746487 °
DWR ID	DWR_RD1500_01_f_2015_114				
Comment Code					
ST : Stairway					
Inspector Comment					
Landowner has dug stairs on the landside slope to irrigation equipment.

Perspective view of the concrete box on the landward side of the levee looking upstream. Fall 2015.

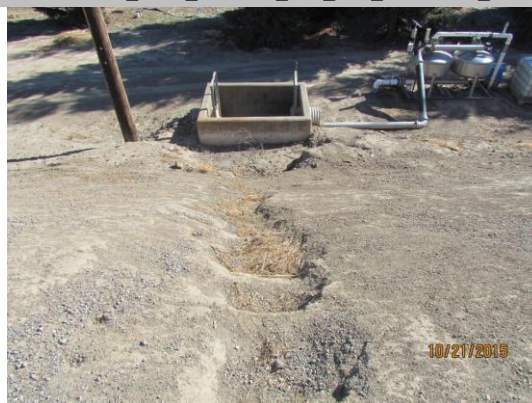
Photo 2 of 3 : FA_2019_RD1500_189_114_20190829_00050.jpg

There is erosion at the levee toe around the concrete box. There are also stairs leading down the slope. Fall 2015.
